# Identification and Analysis of Partial Shading Breakdown Sites in $\text{CuIn}_x\text{Ga}_{(1-x)}\text{Se}_2$ Mini-Modules

## Study

This study replicated partial shading conditions across CIGS mini-modules by reverse-bias stressing to characterize resulting failure. Localized thermal runaway and breakdown results in ‘wormlike’ permanent defects. EL and DLIT imaging and current-voltage curves were used to study these sites.

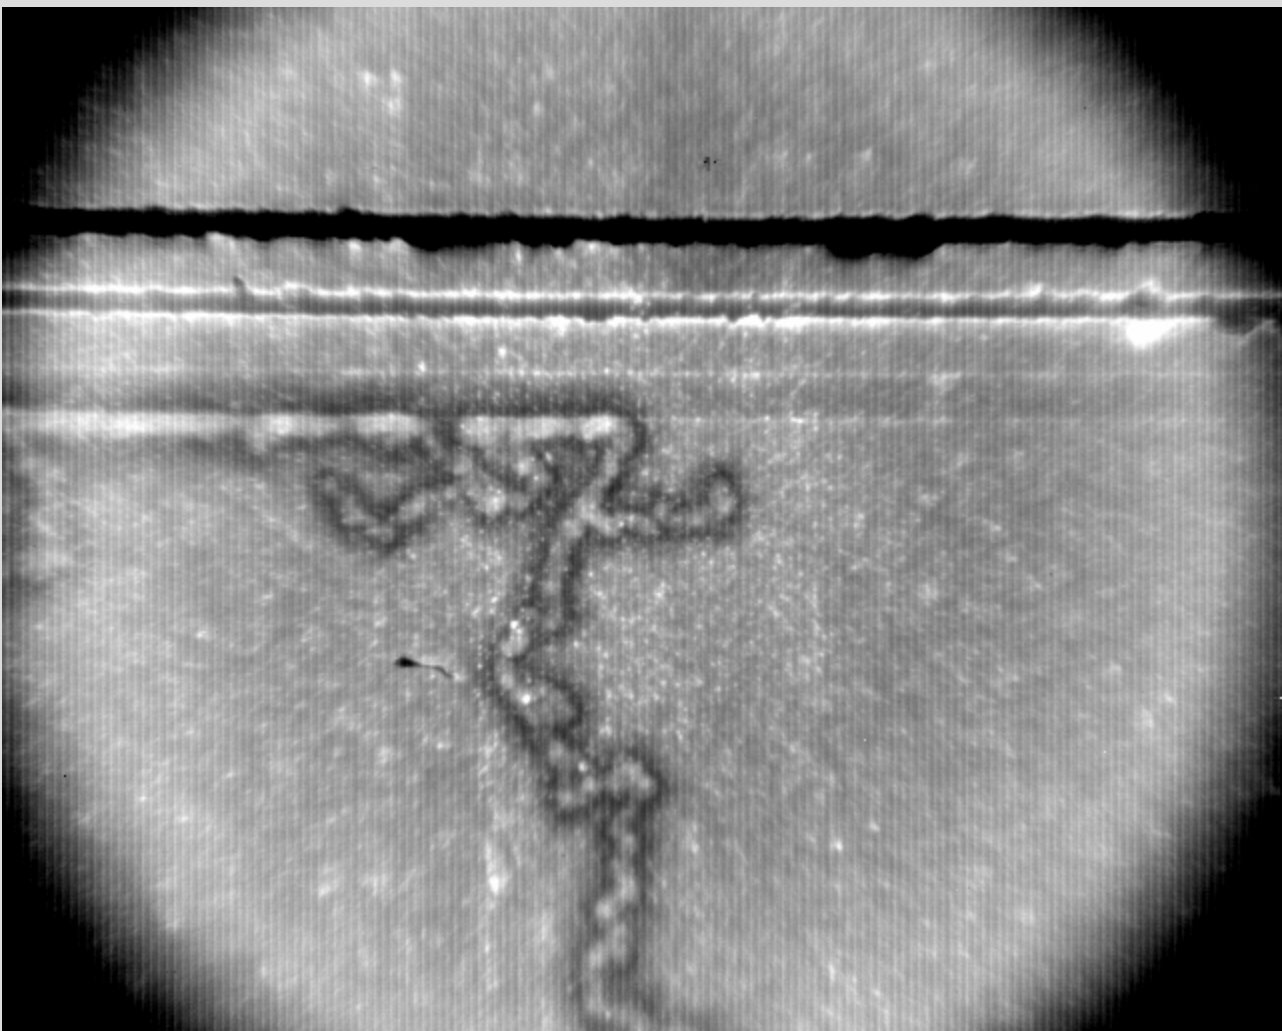
‘Wormlike’ defect on CIGS mini-module.

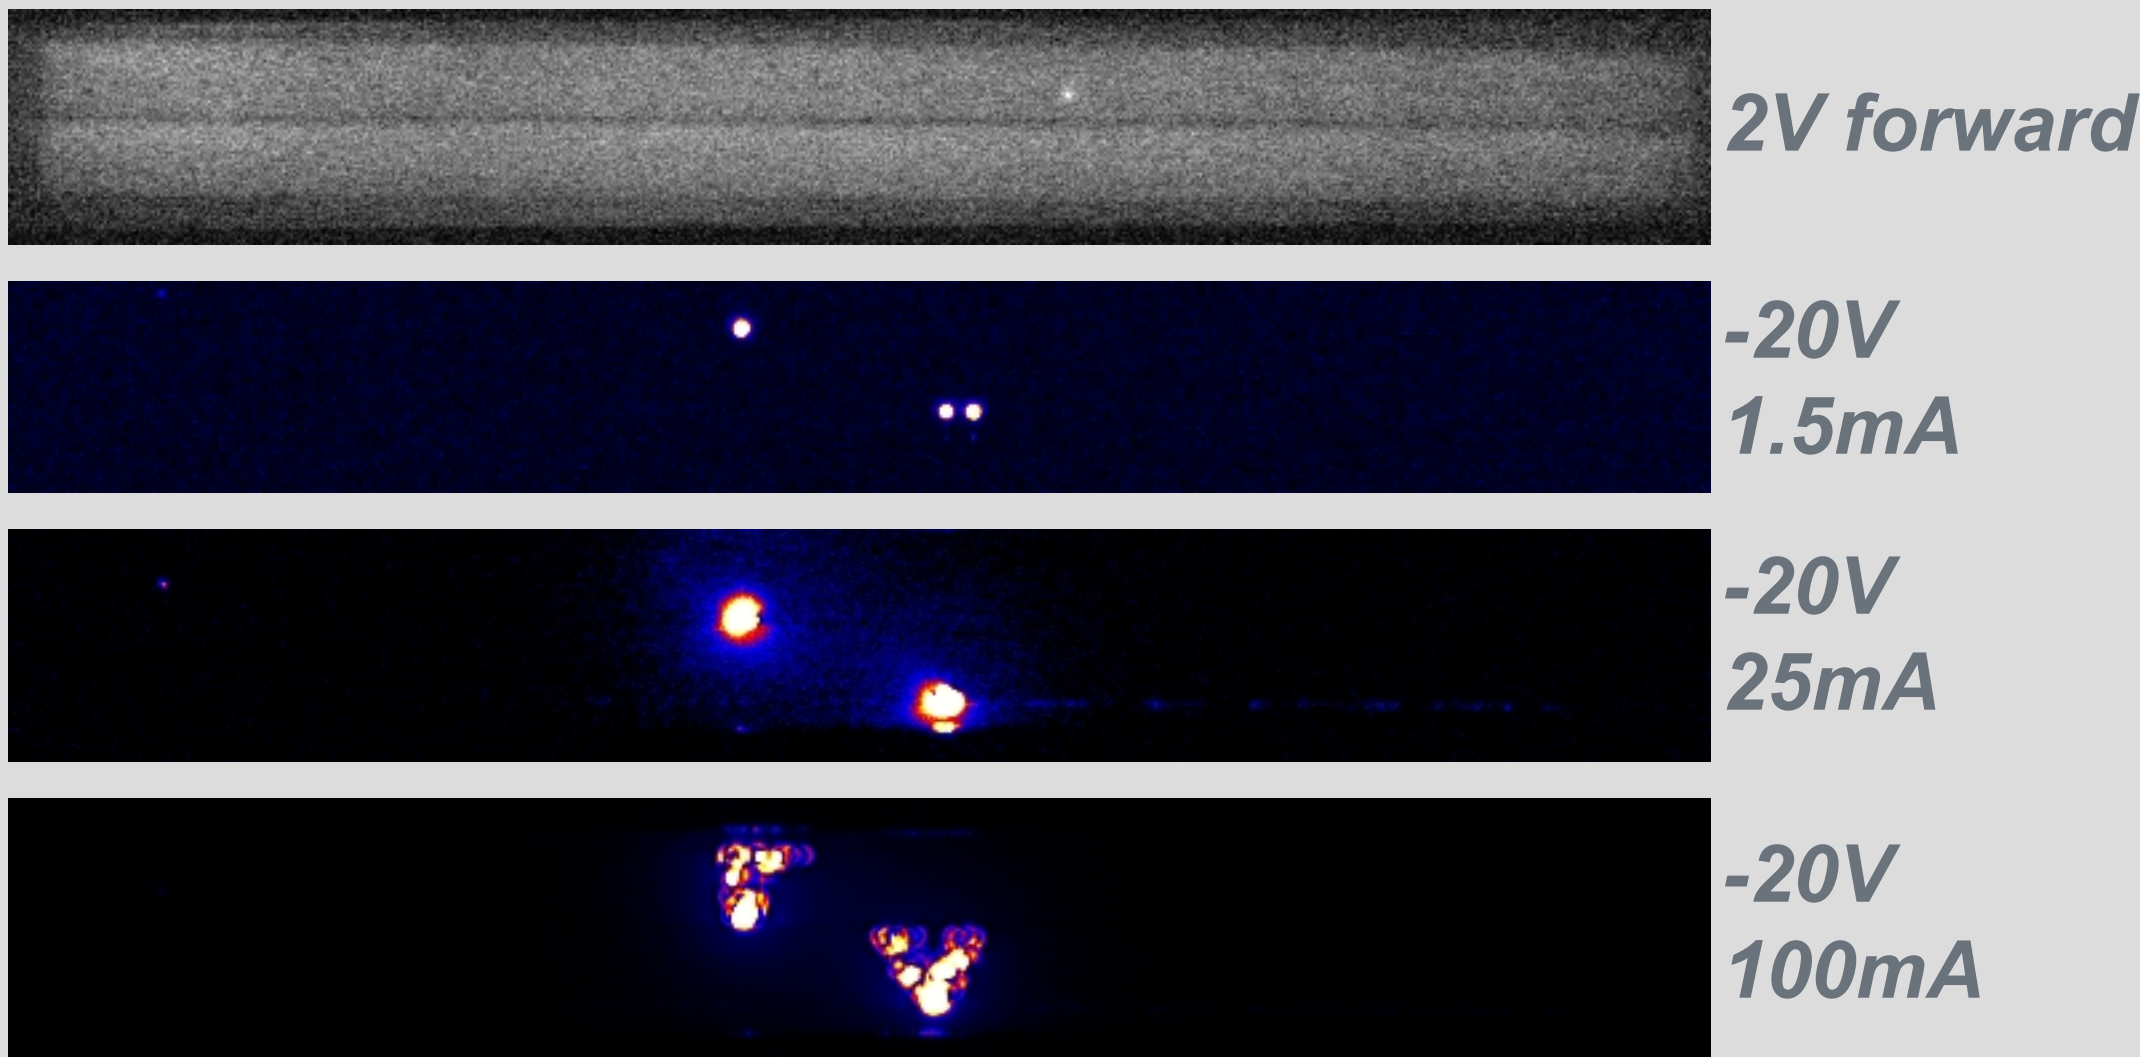
DLIT images of reverse-bias stressing of c4c5 of Module 5.

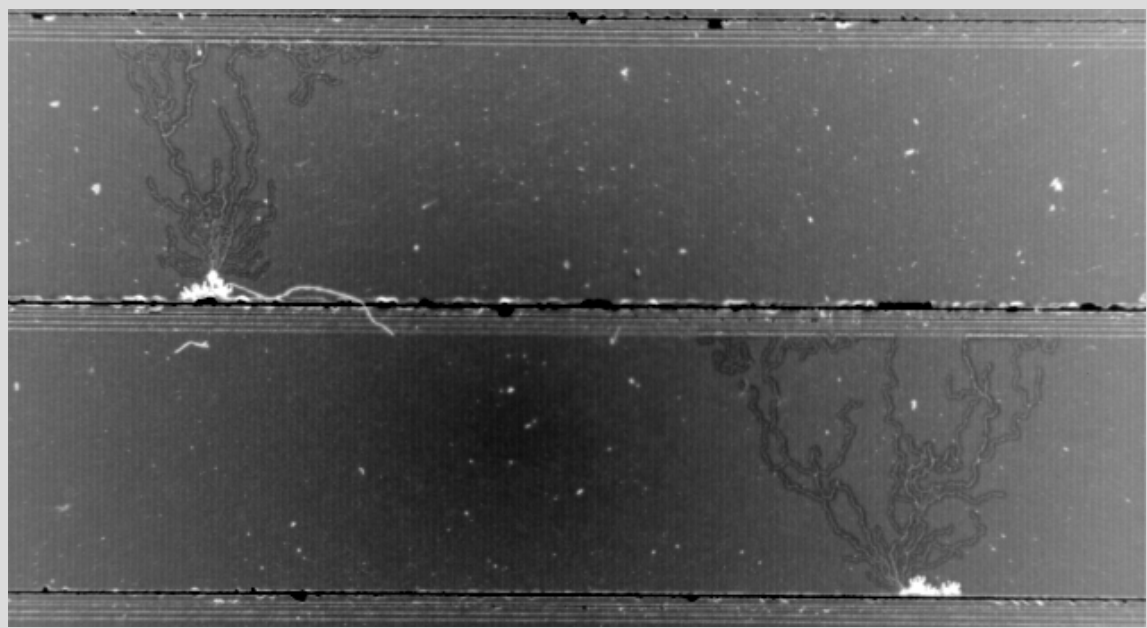
Thermal image of wormtrails from breakdown of cells 4 and 5 of Module 5.

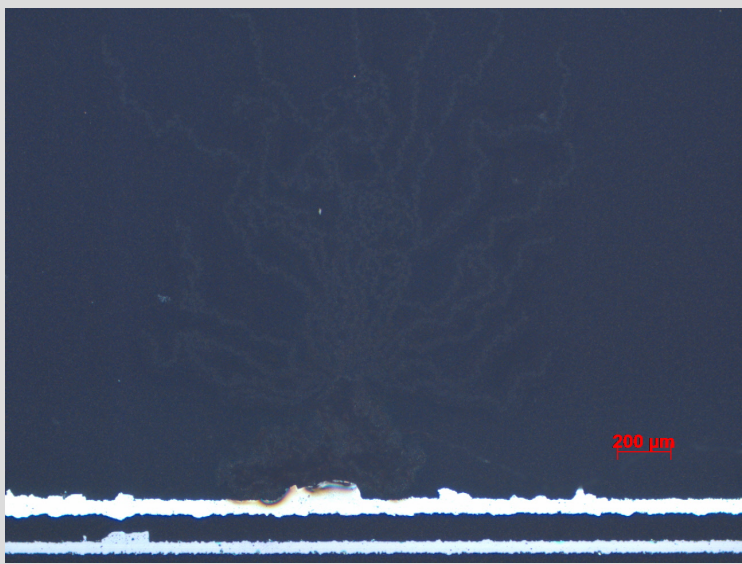
Optical image of cell 4 wormtrail.

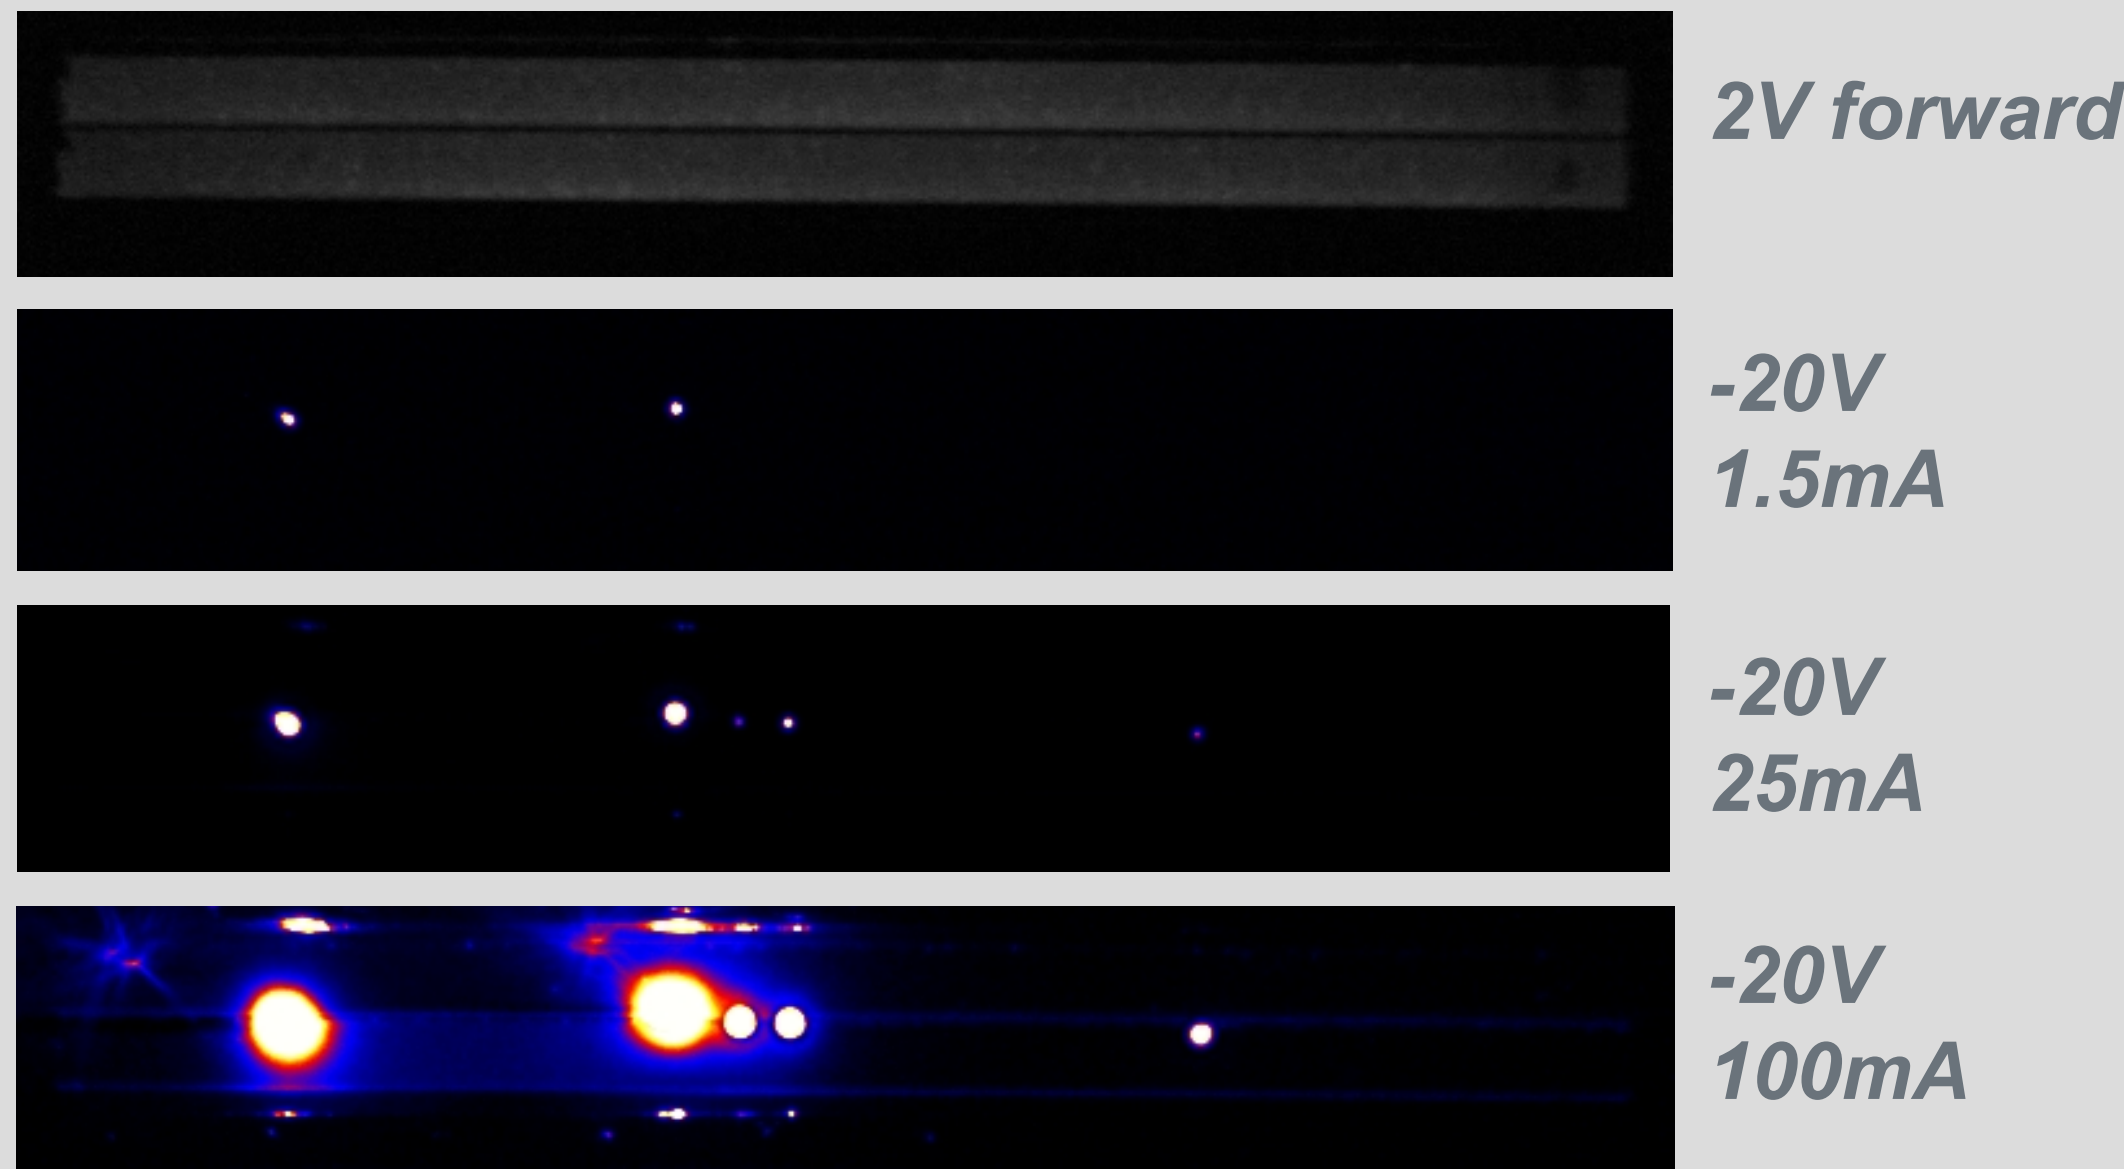
DLIT images of reverse-bias stressing of c9c10 of Module 2.

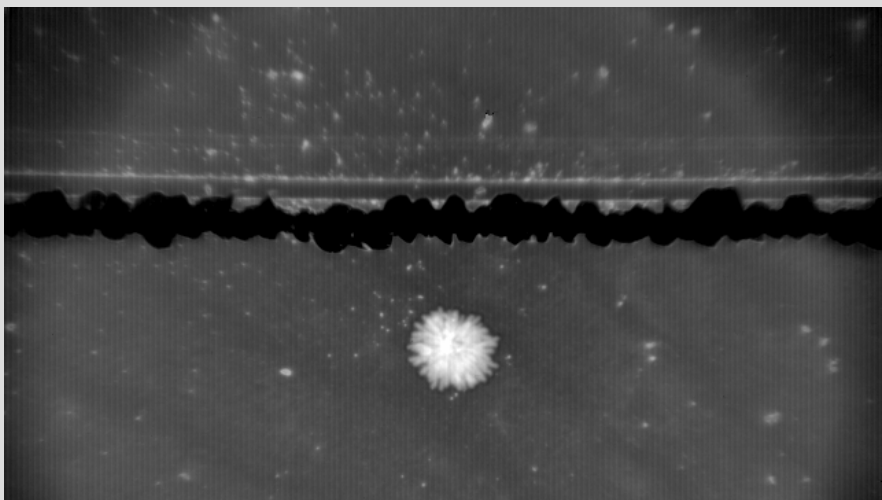
Wormtrail of left-most breakdown site.

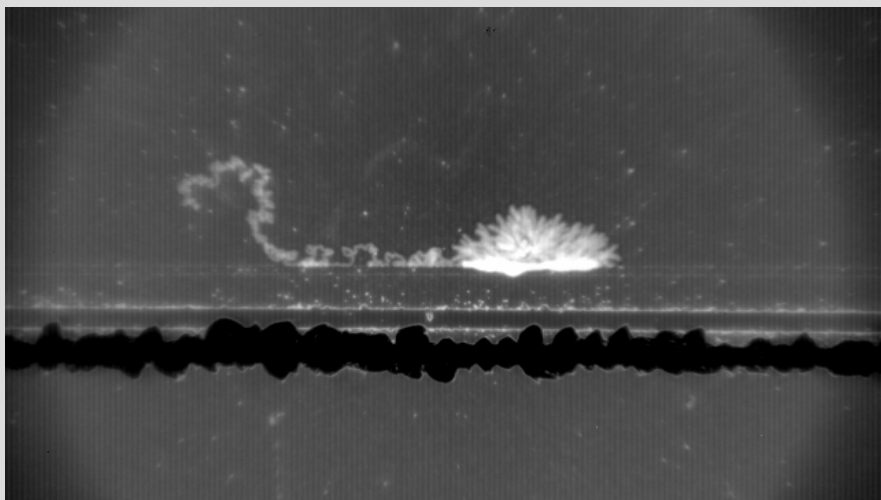
Wormtrail of right-most breakdown site.

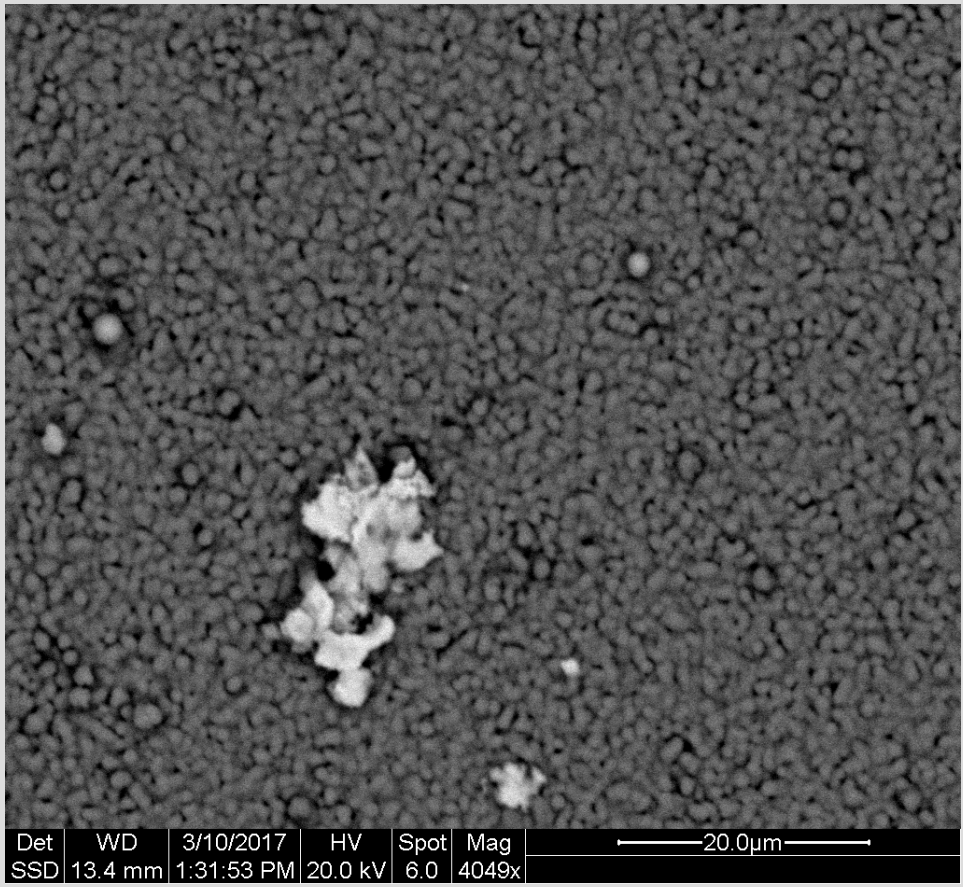
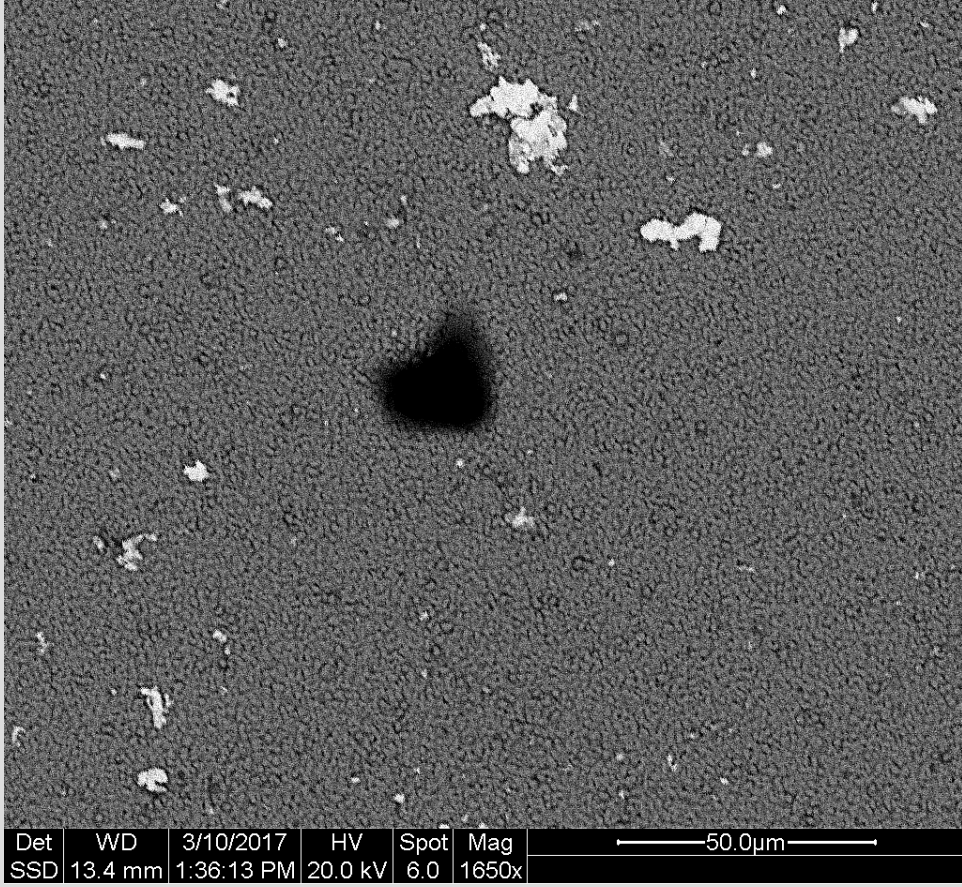
ESEM/EDS was performed on localized hotspots and revealed no areas of concern on the module surface.

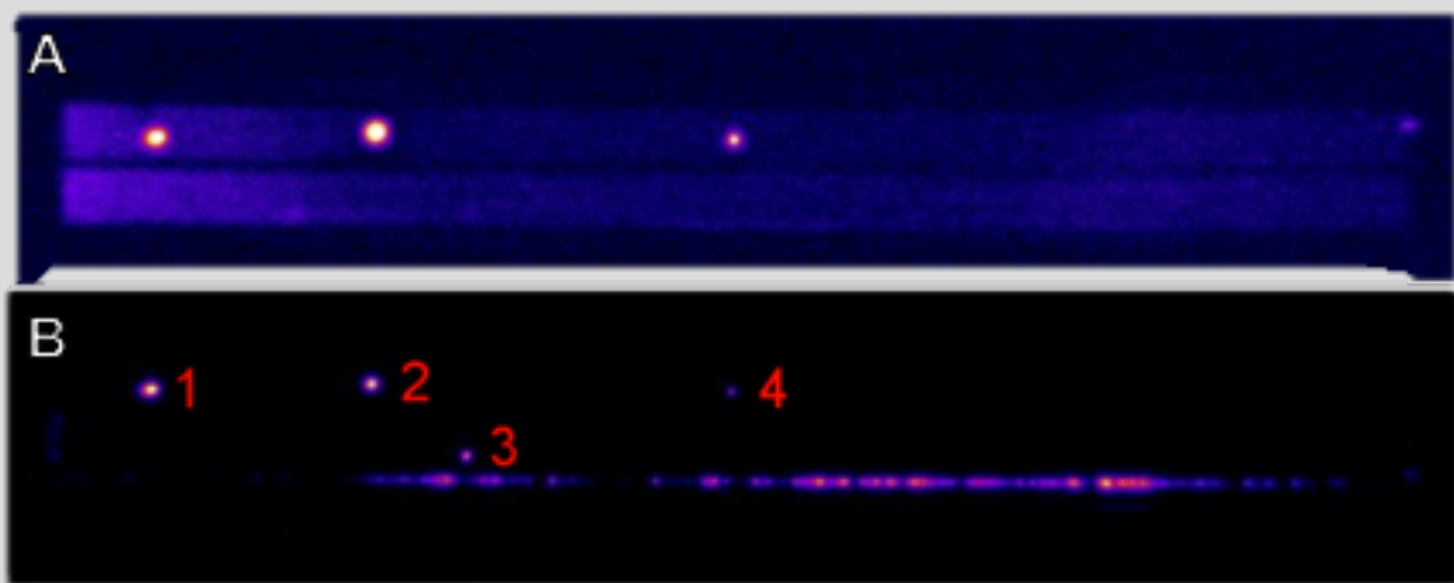
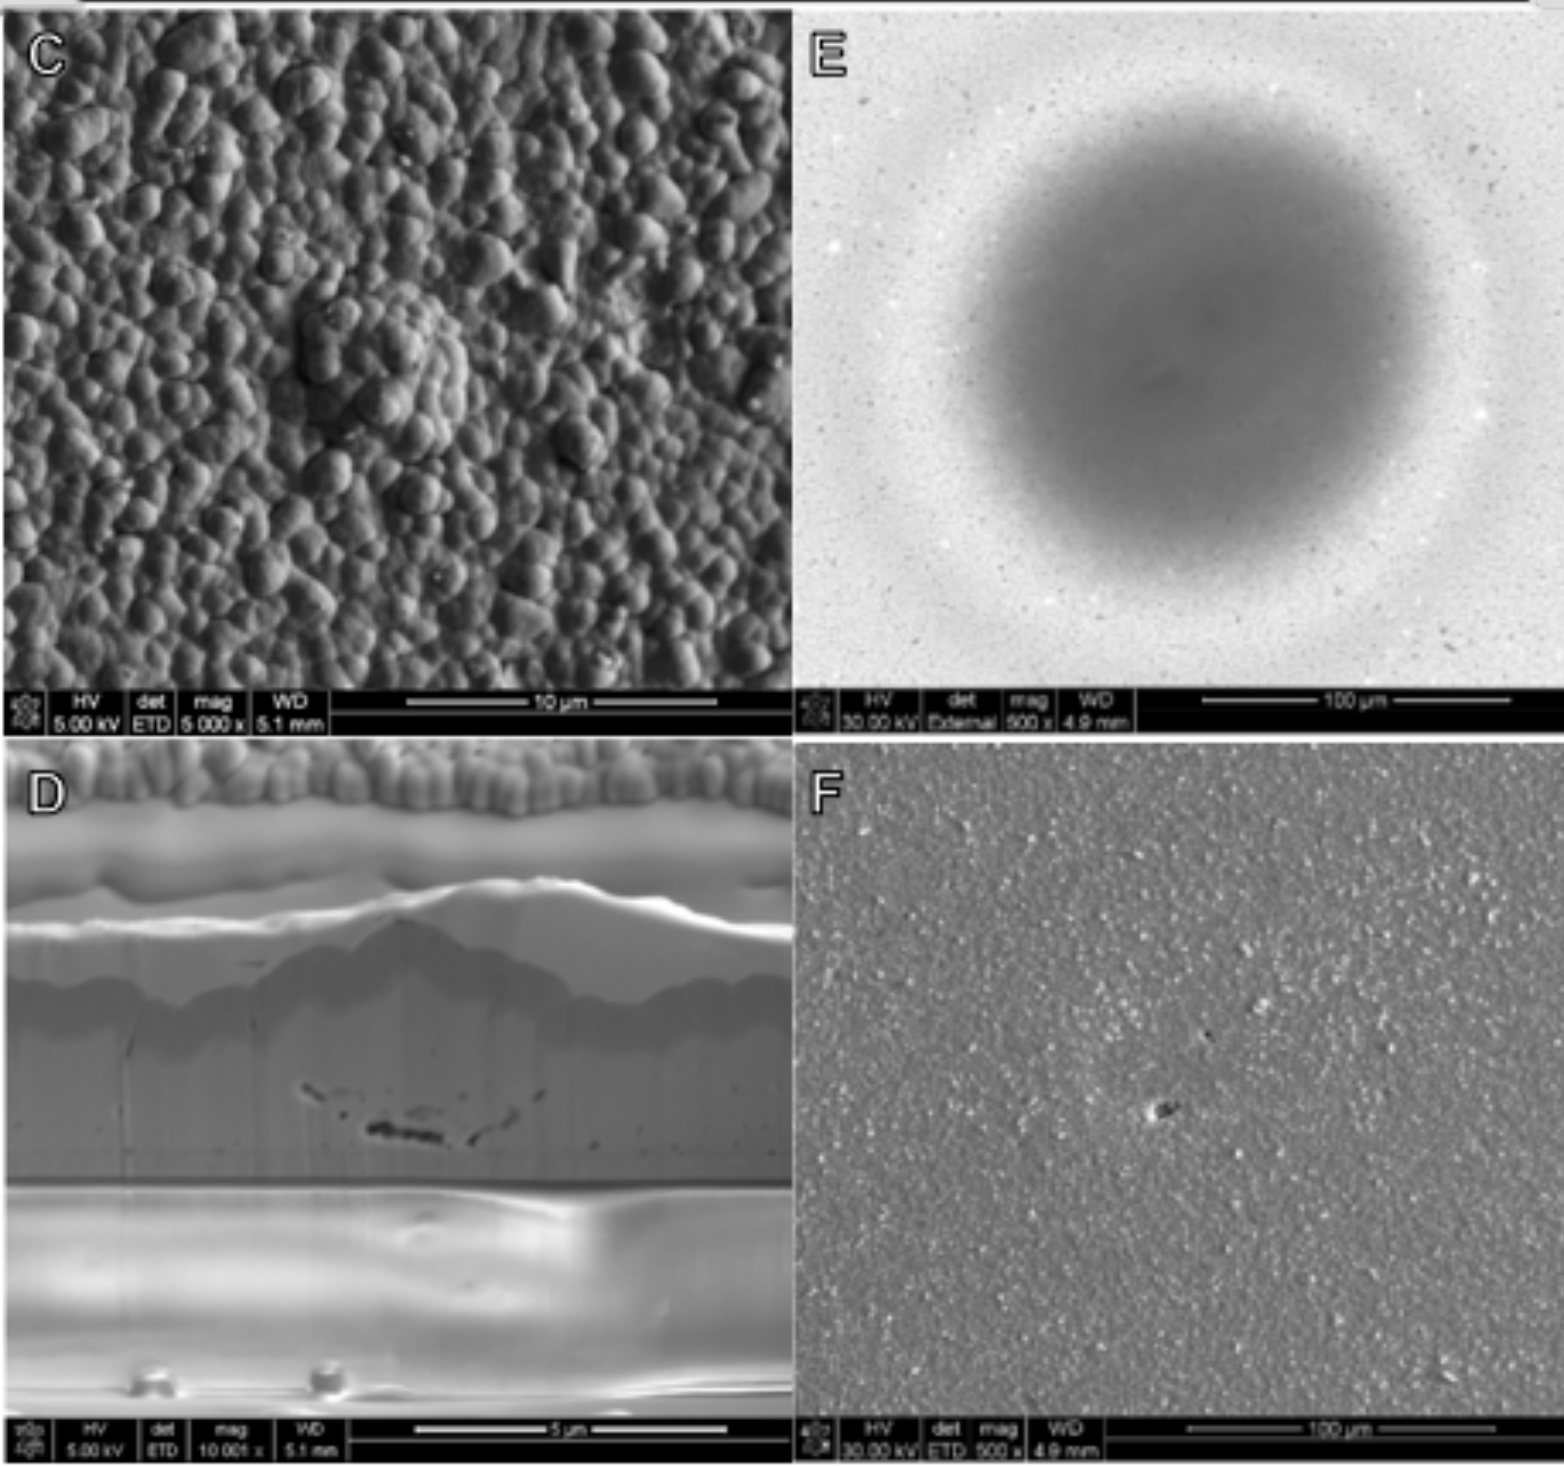
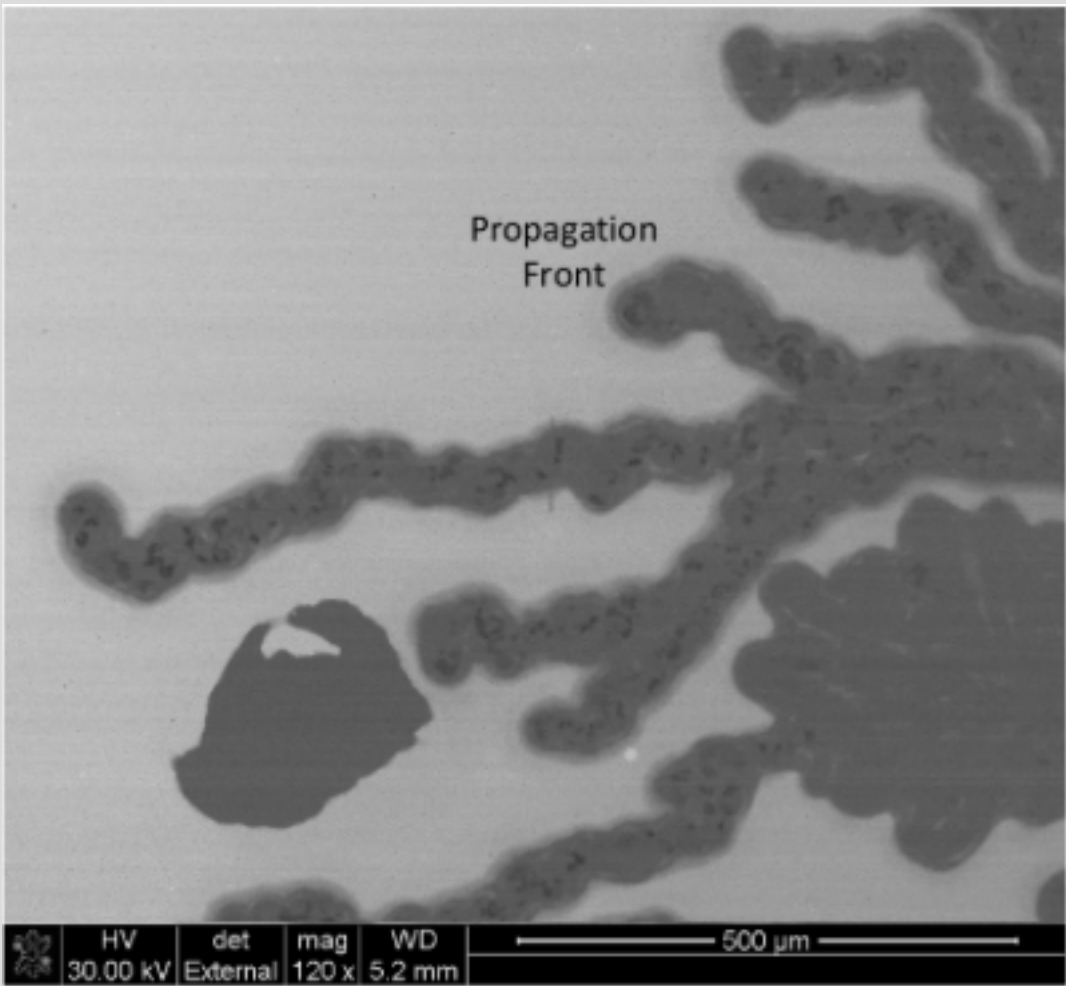
Different imaging techniques were used to analyze two stressed cells. A and B are the forward and current-limited reverse bias cells, respectively. C and D are the SEM and FIB cross-section of defect 3, respectively. E and F are EBIC and SEM images of defect 4, respectively. Defects 1, 2, and 4 are crater-like. Defect 3 is nodule-like.

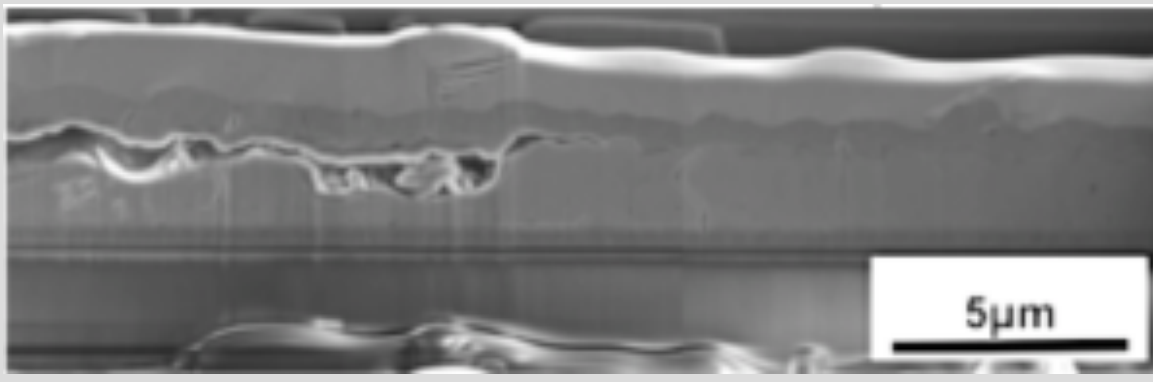
SEM and FIB images originating in a permanently damaged wormtrail and moving into the non-damaged region.
